PTPD REPORT NO. 77-4 AFPEA PROJECT NO. 76-P7-61

CNU-XXX (PROPOSED CONTAINER FOR CBU-75/B)
ROUGH HANDLING, VIBRATION, AND MECHANICAL
HANDLING TEST

AFALD/PTPD
AIR FORCE PACKAGING EVALUATION AGENCY
WRIGHT-PATTERSON AFB OH 45433

January 1977

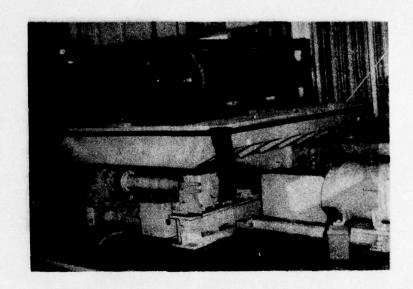
FIGURE 6. VIBRATION TEST

1. Vibration (Test #A-1). (See Figure 6, page 13.) The equipment used to conduct vibration testing was a L.A.B. Vibration Machine, Serial 56801, Type 5000-96B. The basic vibration platform was fitted with a table adapter constructed of plywood measuring 96" long by 96" wide by 1.5" thick bolted to the original vibration platform. The container was vibrated on this platform at 4.5 Hz for 22 minutes. The 4.5 Hz was selected as the vibration frequency because at his point, the container was receiving a 1G shock from the 1" double amplitude displacement.

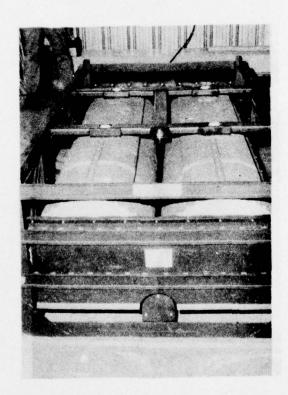
FIGURE 13. TOP VIEW OF PROTOTYPE II

At this point, testing of the prototype I container was terminated and plans were developed for testing of the prototype II container. This container (see Figure 13, page 16) arrived on 30 November 1976 and was tested on 1-3 December 1976. The results are shown in the following paragraphs.

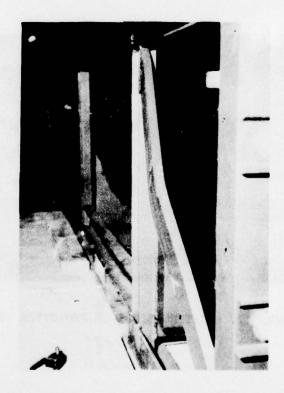
- 7. Cornerwise Drop (Test #B2-2). The procedure for this test follows exactly the procedure outlined in test #B2-1 above. Results of this test indicate that in all places where there was previous deformation of a structural member, that deformation increased (see Figure 15, page 17).

FIGURE 15. INCREASE IN DAMAGE
